SARGILL LEAD SMELTING MILL

NORTH YORKSHIRE

Report on Archaeological Survey

Report no 1997-98/(020)/7682

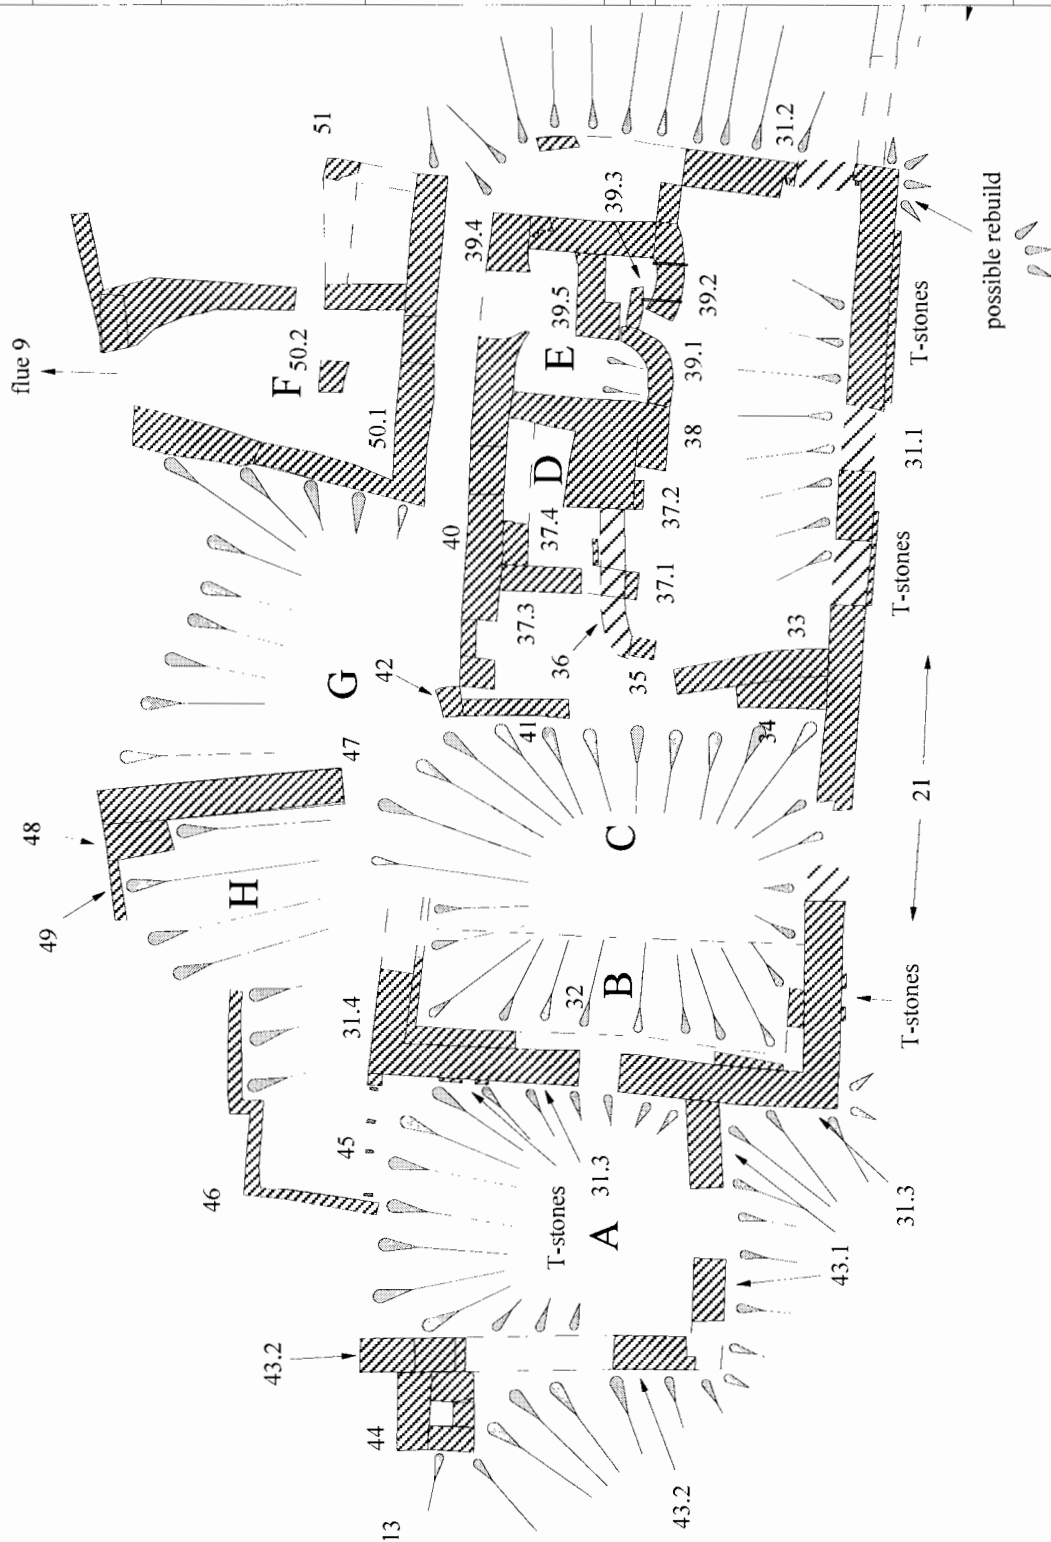
Fig 5 Smelt Mill Building Plan

- 4.4.6 Internally, the mill comprised four cells. The western cell contained the wheel pit (SAR 32) and presumably the blowing mechanism; it contained the larger doorway of 31.1 in its south elevation. An aperture (SAR 42) in the north end of the eastern wall of this cell was observed to a depth of at least 2.0m. This opening probably carried the air pipes from the blowing mechanism, leading into the space behind the

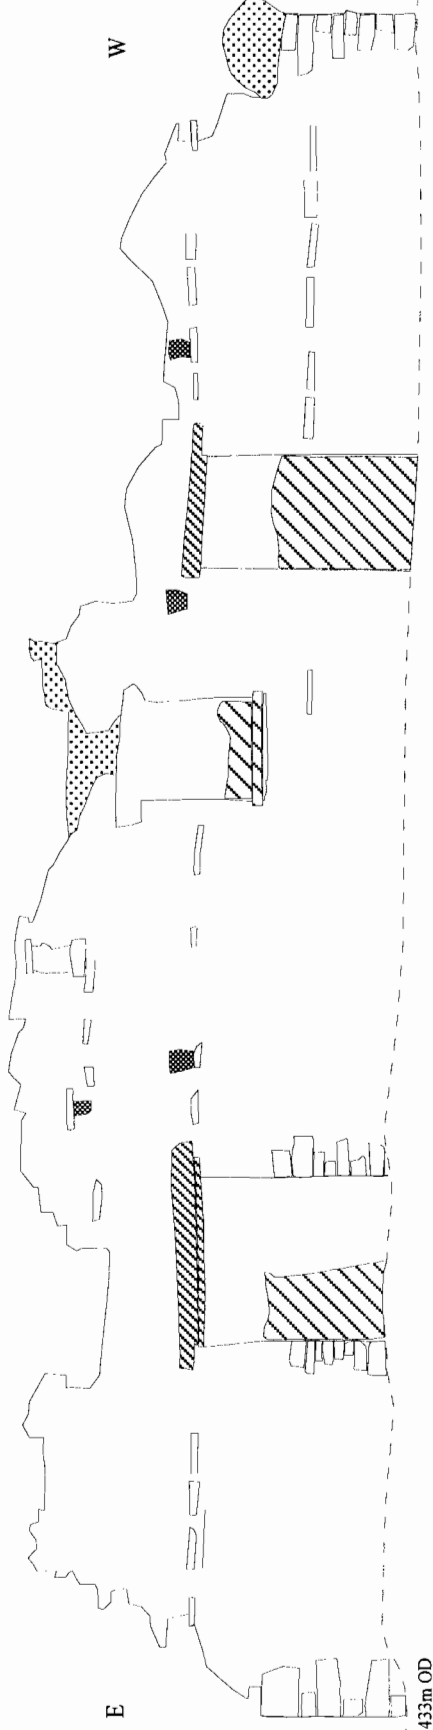
Fig 7 Elevation 5

- 4.4.3 The southern wall (SAR 31.1: Fig 7) was the best preserved and contained two doorways and one window. The western doorway, now partially blocked, was large enough for a loading door, and sockets for a pair of barn doors were observed in the lintel. The window and smaller doorway were fully blocked. The eastern end of this wall displays a subtle difference in the masonry; the quoins were smaller, suggesting a possible rebuild of this south-east corner of the building.

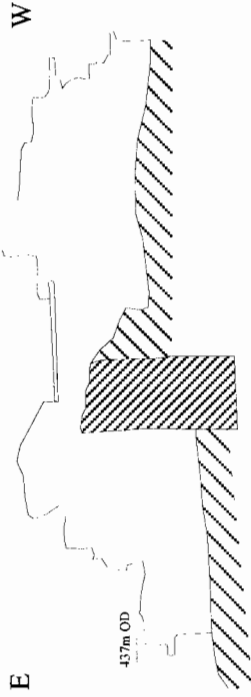
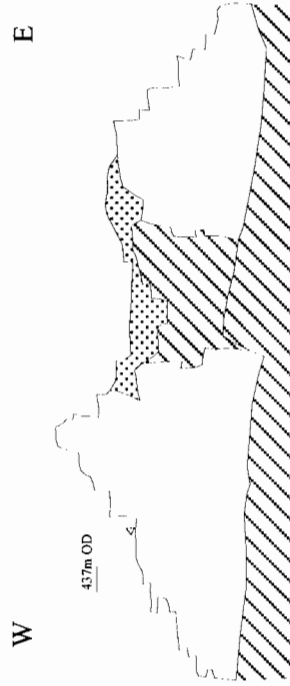
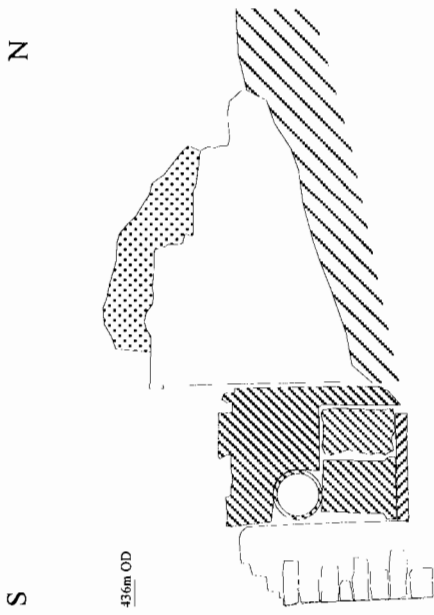
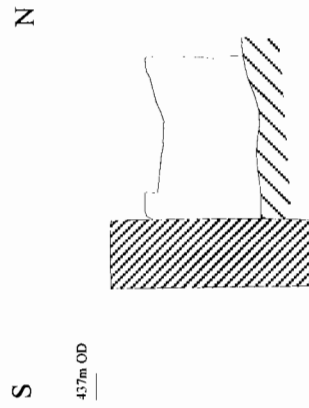
Fig 11 Elevatons 15, 16, 17 and 18

- 4.4.4 The eastern wall (SAR 31.2: Fig 11) was badly preserved, and the northern end was obscured under rubble collapse. It contained one small doorway, presently blocked by large salt-glazed pipes. No through stones were observed in this elevation, and the build appeared to be slightly different to the southern and western elevations; it may be part of the same possible rebuild identified in the southern elevation.
